# Determination of air permeability, resistance to water penetration and resistance to wind load according to EN 13241-1

DOCO Industrial door with Tecsedo panels

Type of door: Daylight size: Industrial, overhead, sectional door Width 4000 mm, Height 3300 mm

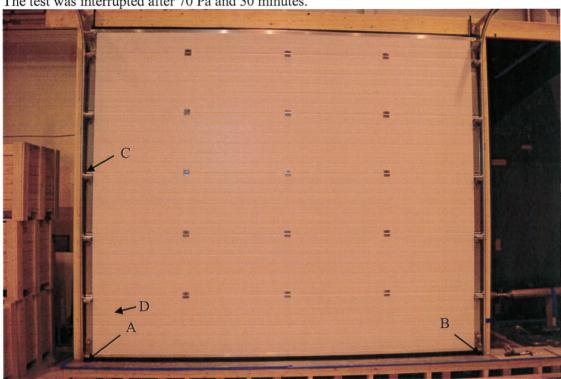
Figure 1. The door as seen from inside.

Air pressure (Pa)	Time (min)	Degree of water leakage at location			
		A	В	С	D
0	0-10	3	0	0	0
10	11-15	3	3	0	0
30	16-20	3	3	0	0
50	21-25	3	3	0	0
70	26-30	3	3	3	3

- A: Leakage at the edge of the bottom sealing
- B: Leakage at the edge of the bottom sealing
- C: Leakage between the panels at the edge
- D: Water runnel on the panel from leakage C

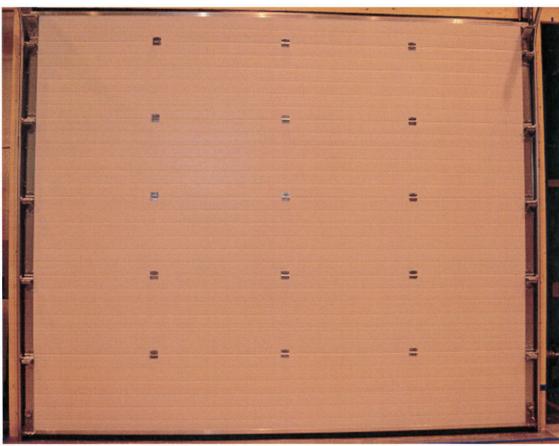
Figure 2. Tested door, DOCO Industrial door with Tecsedo panels, mounted in the test rig, as seen from inside.

The door was supplied and installed by the client in the opening of an airtight chamber, with its exterior facing inwards towards the chamber, see description and pictures in appendix 1.

Daylight size 4000 x 3300 mm

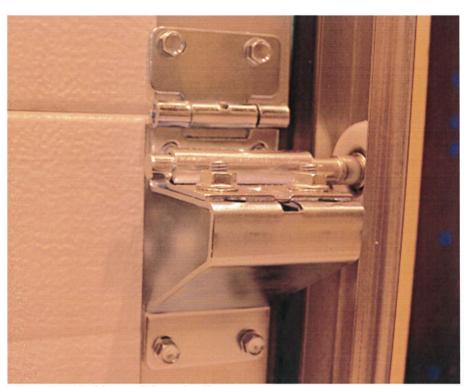
Figure 3. Side hinge, slide and roller.

DOCO 25334

DOCO 25238

DOCO 25010-E

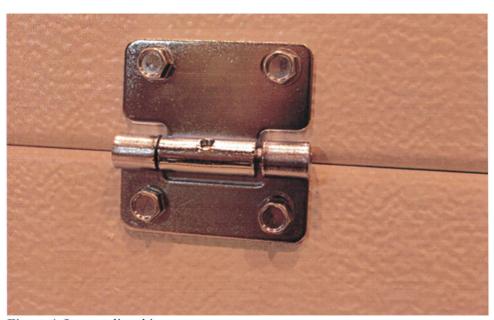
Figure 4. Intermediate hinge.

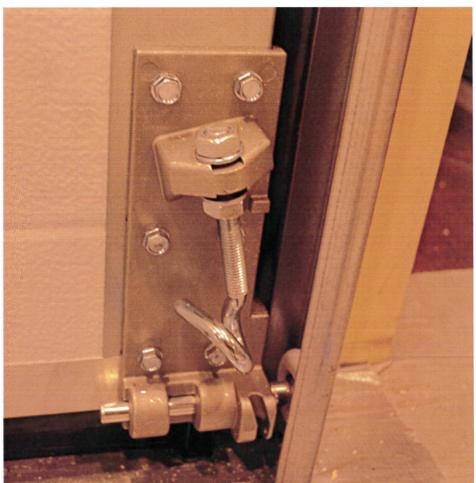
Figure 5. Bottom bracket.
